Manhole Inspection Summary

Manhole # S51A__010MH

Insp Date: **6/27/08 11:58 AM**

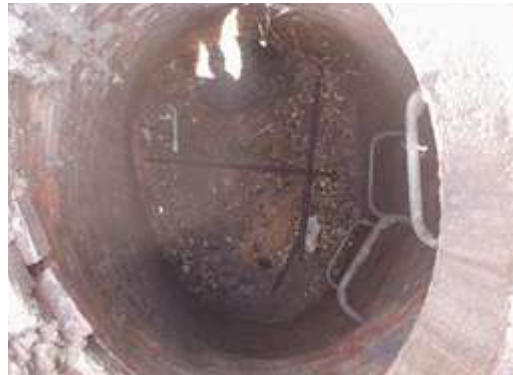
Top View

Condition: ☐ Sound ☐ Cracked ☐ Root Intrusion ☒ **Loose Brick** ☐ Deteriorated

Infiltration: ☐ None ☐ Joint ☐ Cracks ☒ **Mortar** ☐ Roots ☐ Wall
